Assessment of Dam Safety of Coal Combustion Surface Impoundments

Indianapolis Power & Light Company

Harding Street Generating Station

November 15, 2010

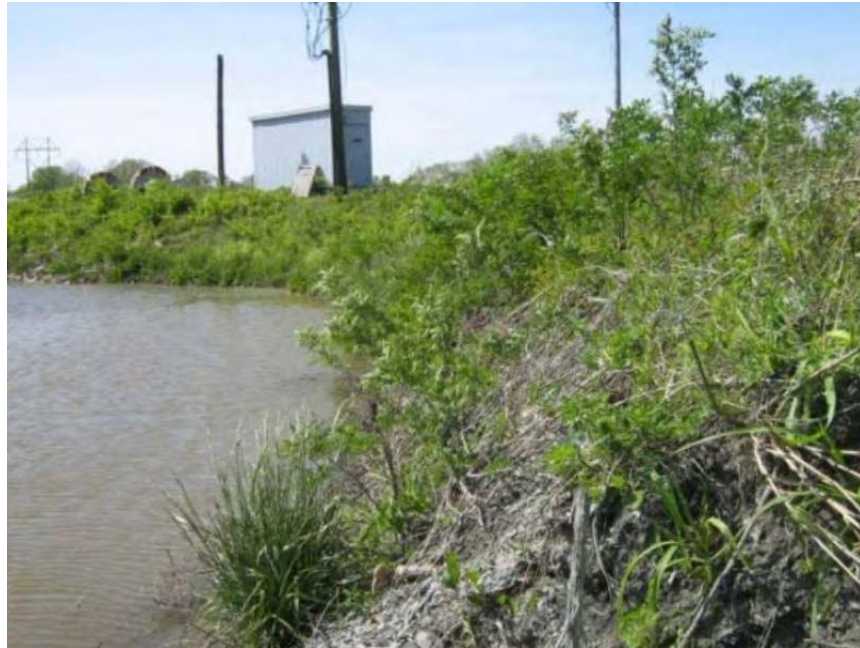
56. Ash Pond 2A - East Embankment Interior Slope, Looking North,
Approximate 1H:1V Slope

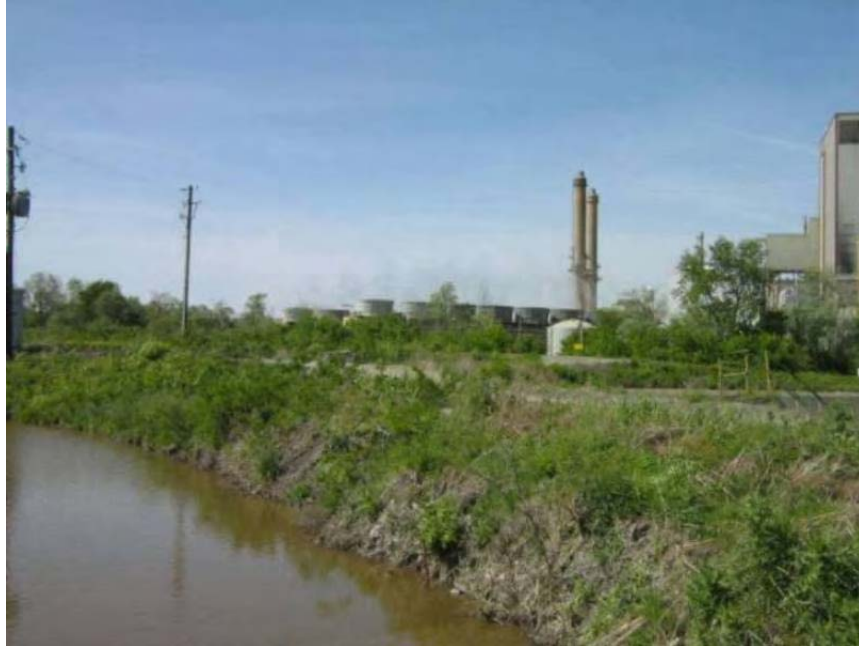
58. Ash Pond 2A - Overview of Steep East Embankment Interior Slope, Looking North, Approximate 1H:1V Slope

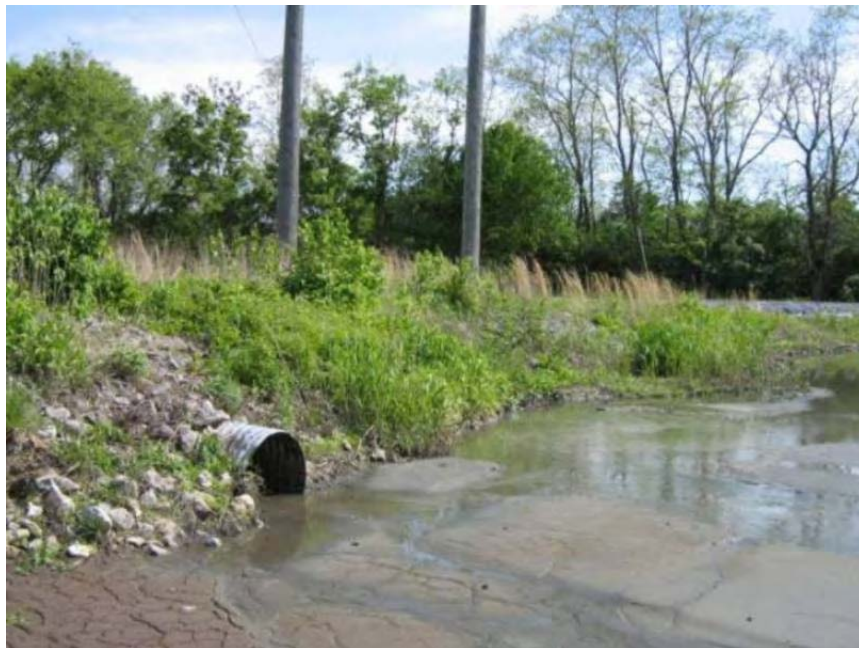
59. Ash Pond 2A - Outlet into Ash Pond 2B along the South Embankment Interior Slope, 30-inch-Diameter CMP

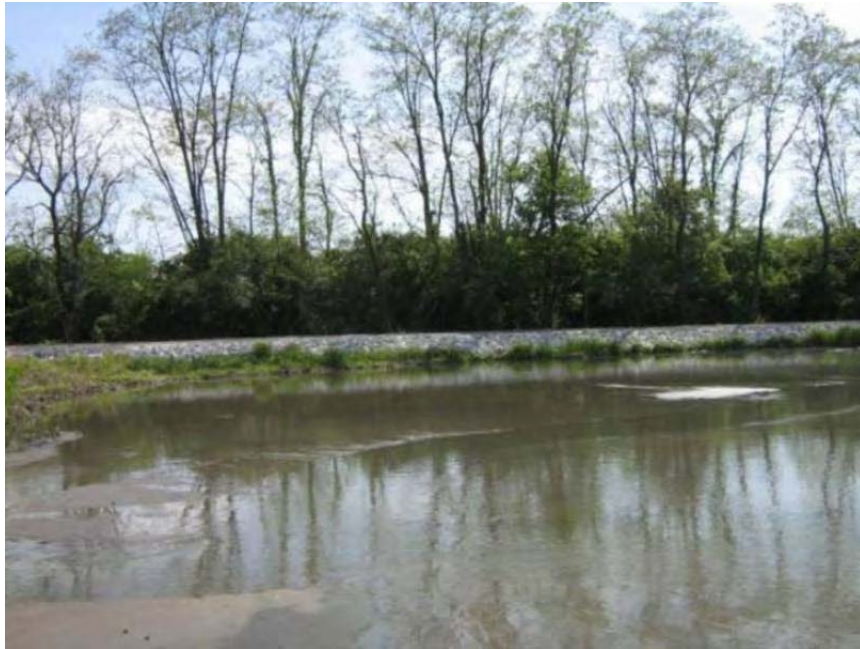
60. Ash Pond 2A - South Embankment Interior Slope, Looking South

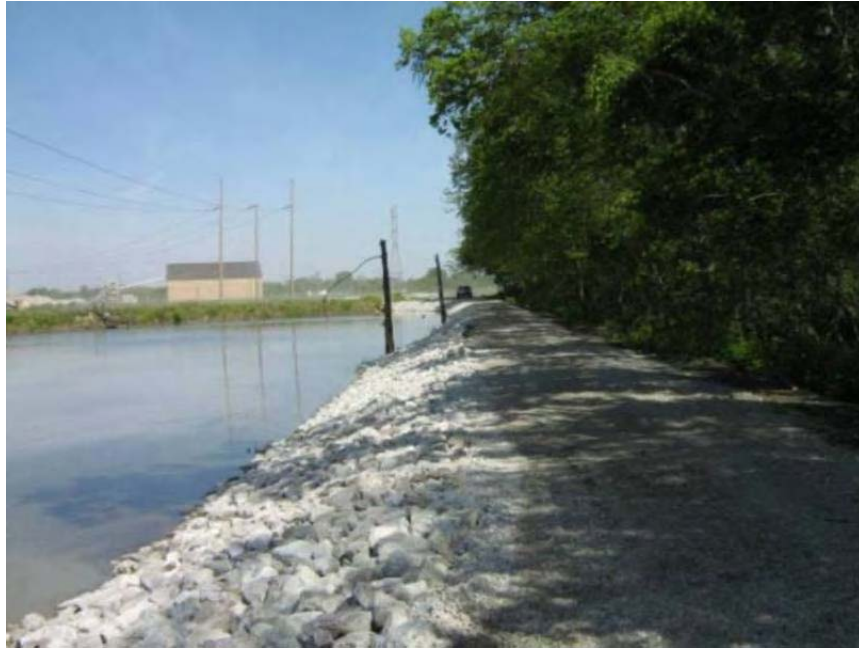
62. Ash Pond 2B - South Embankment Crest and Interior Slope,
Looking East

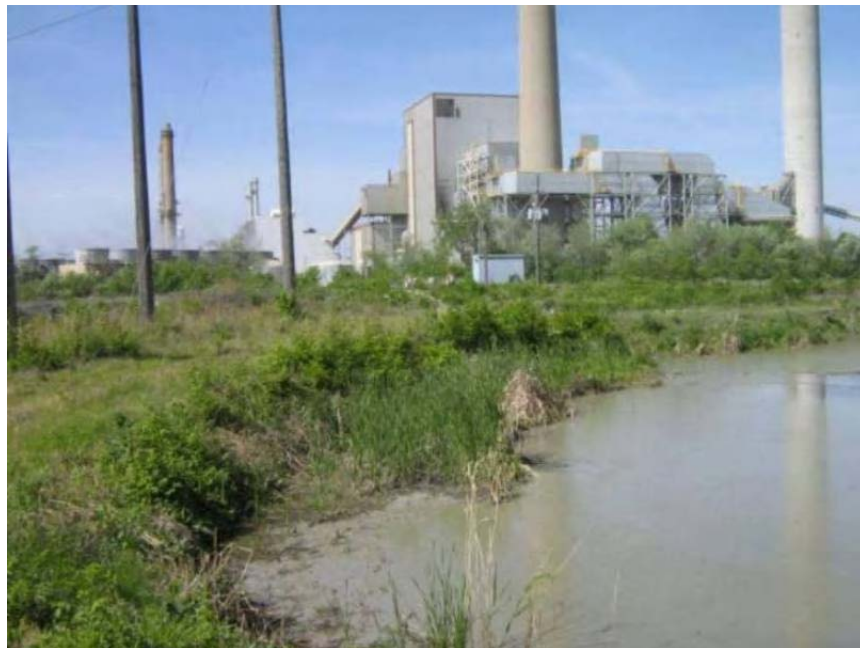
63. Ash Pond 2B - West Embankment Interior Slope, Looking North

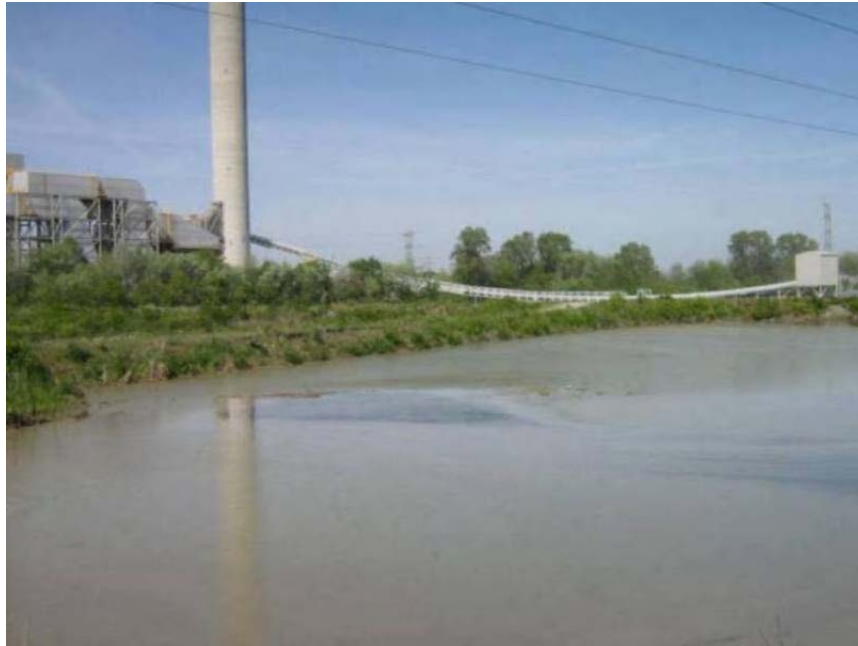
64. Ash Pond 2B - North Embankment Interior Slope, Looking North

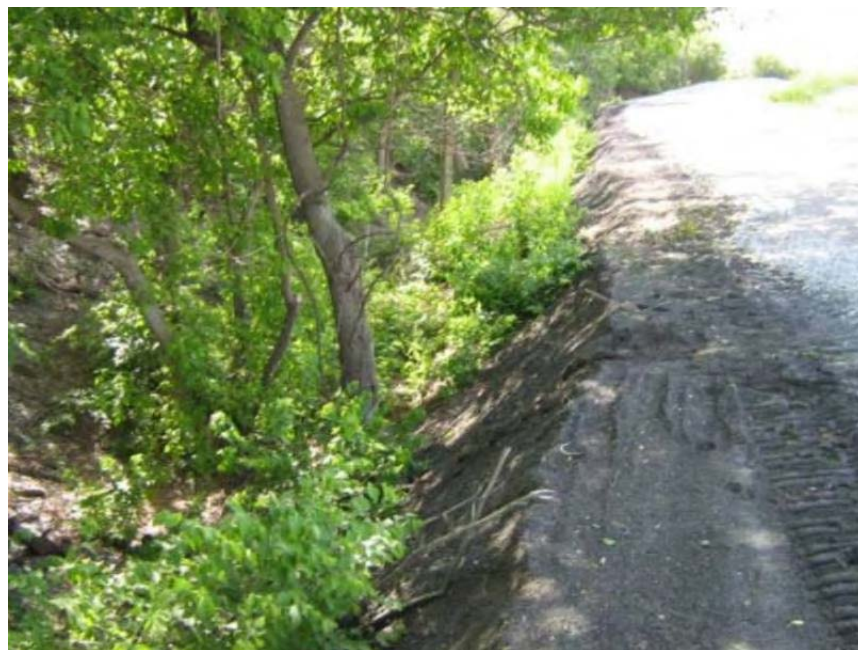
65. Ash Pond 2B - Vegetation along South Embankment Exterior Slope

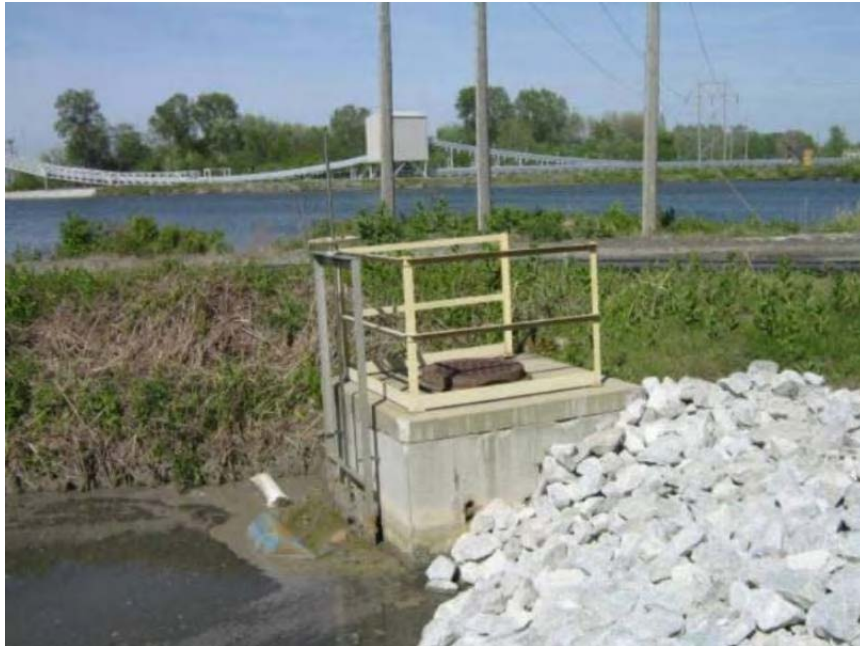
66. Ash Pond 2B - Outlet Structure at East End of South Embankment

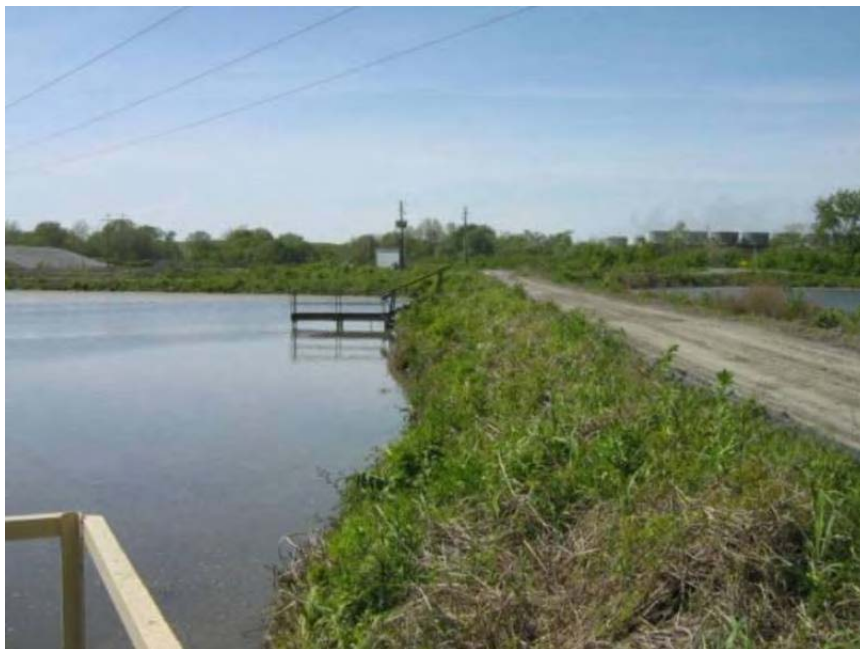
67. Ash Pond 2B - East Embankment Interior Slope, Looking North, Vegetation and Steep Slopes

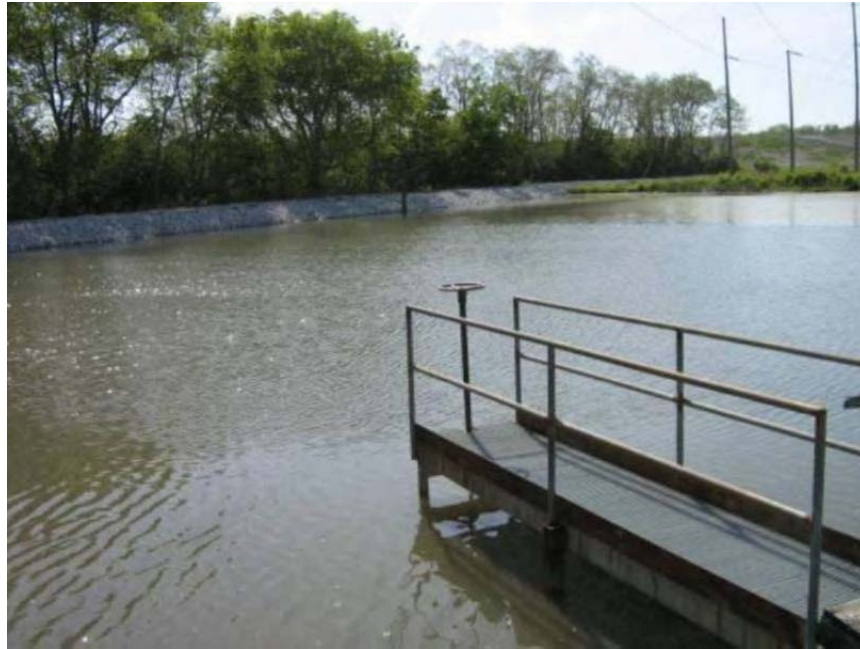
68. Ash Pond 2B - Valved Outlet Access from East Embankment

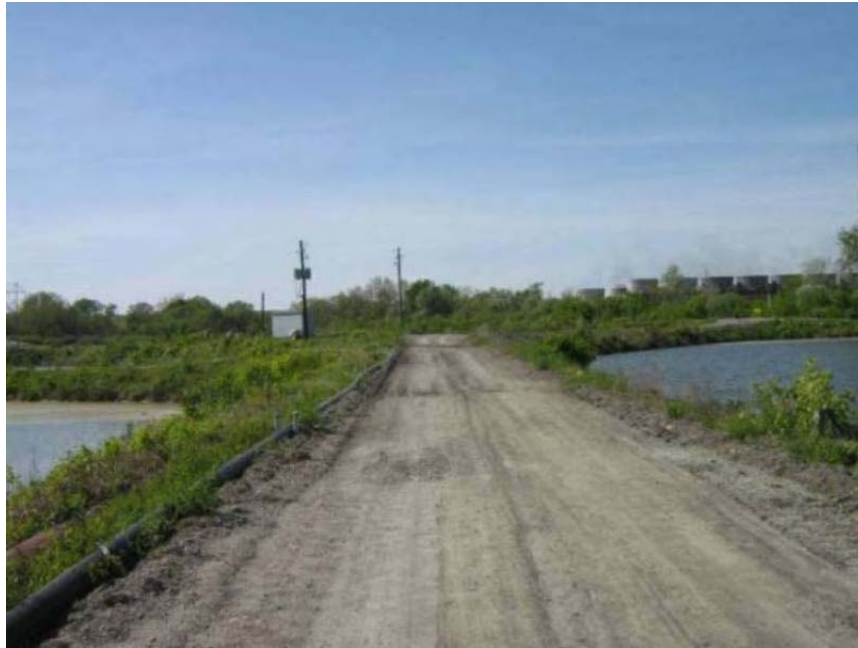
70. Ash Pond 2B - East Embankment Crest, Looking North

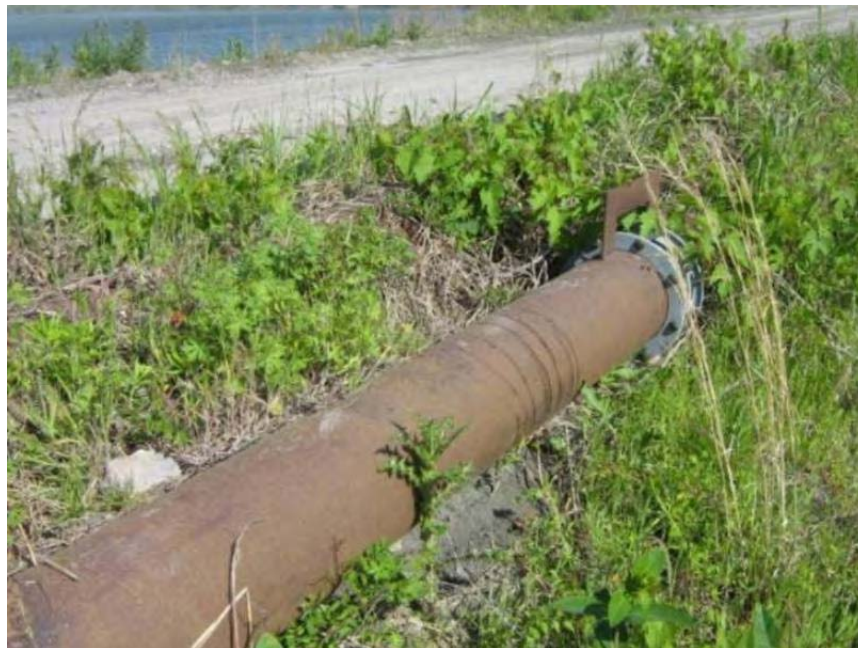
71. Ash Pond 2B - Erosion below Sluice Line along the East Embankment Interior Slope

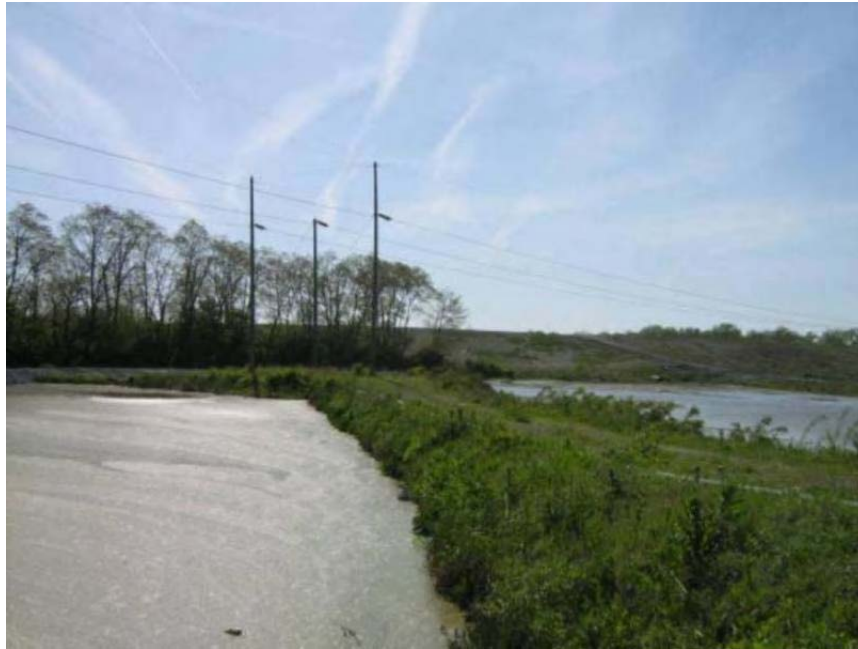
72. Ash Pond 2B - North Embankment Interior Slope, Looking West

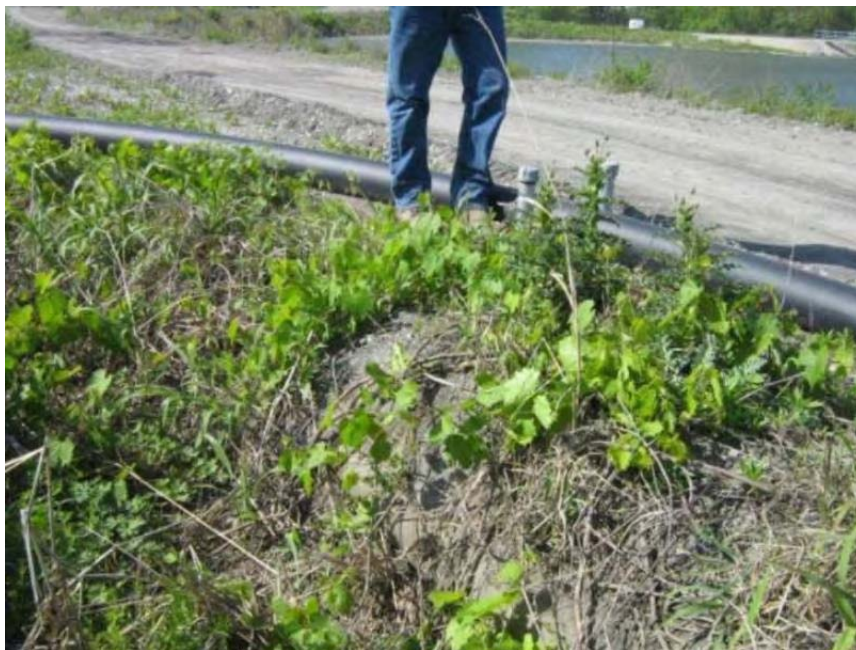
73. Ash Pond 2B - Scarp on Northeastern Embankment Interior Slope

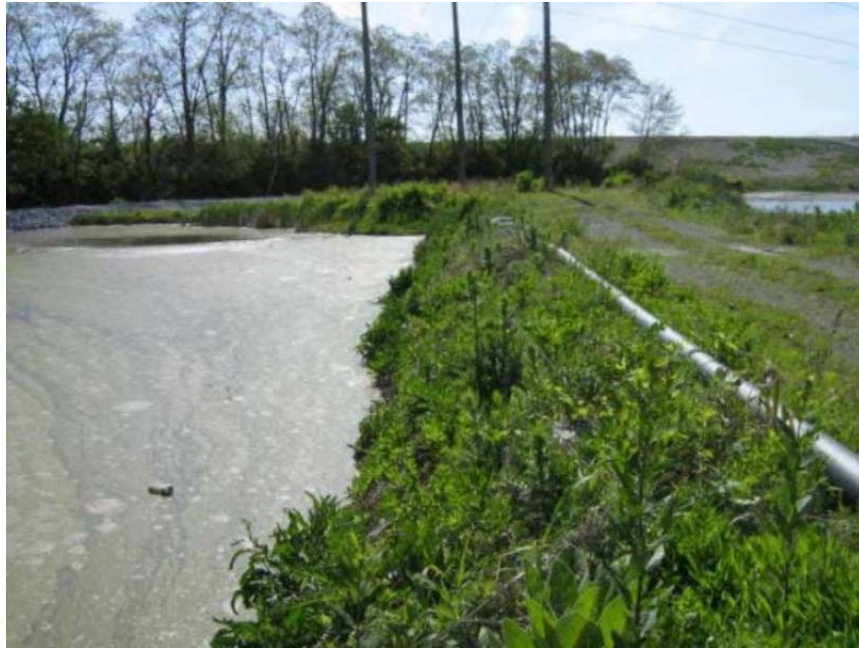
74. Ash Pond 2B - North Embankment Interior Slope, Looking West

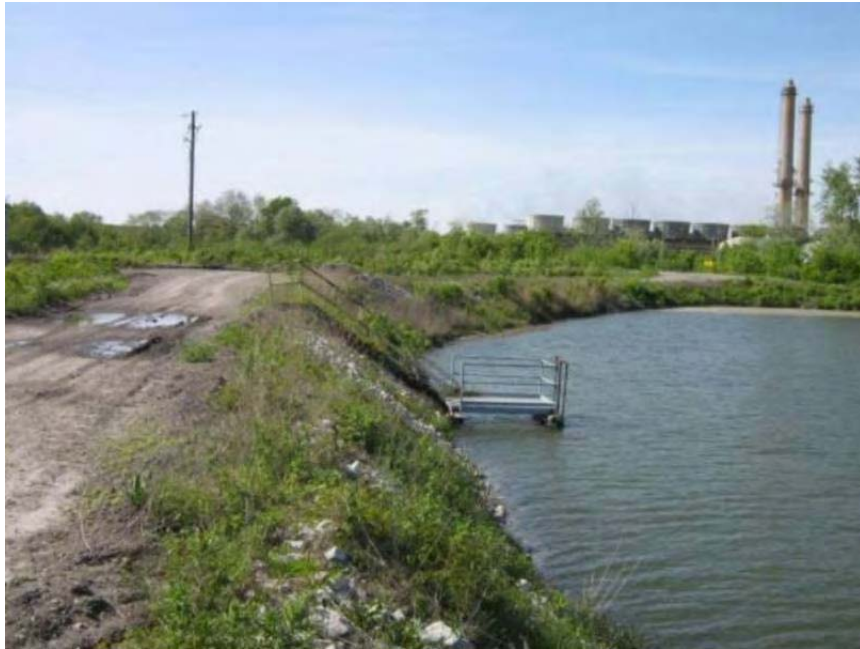
75. Ash Pond 3 - Inlet (3 Valves) Along West Embankment Interior Slope, Looking North

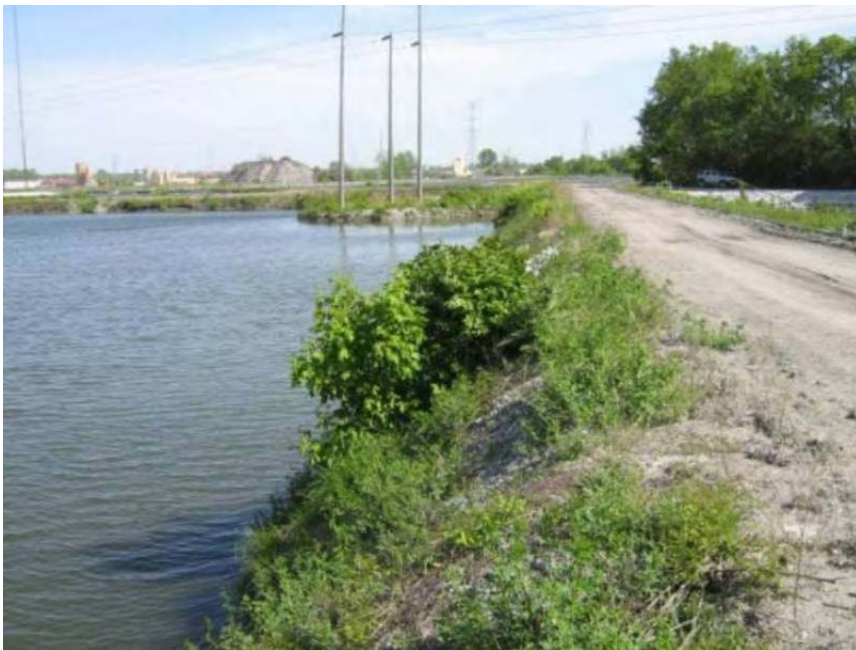
76. Ash Pond 3 - West Embankment Interior Slope, Looking South

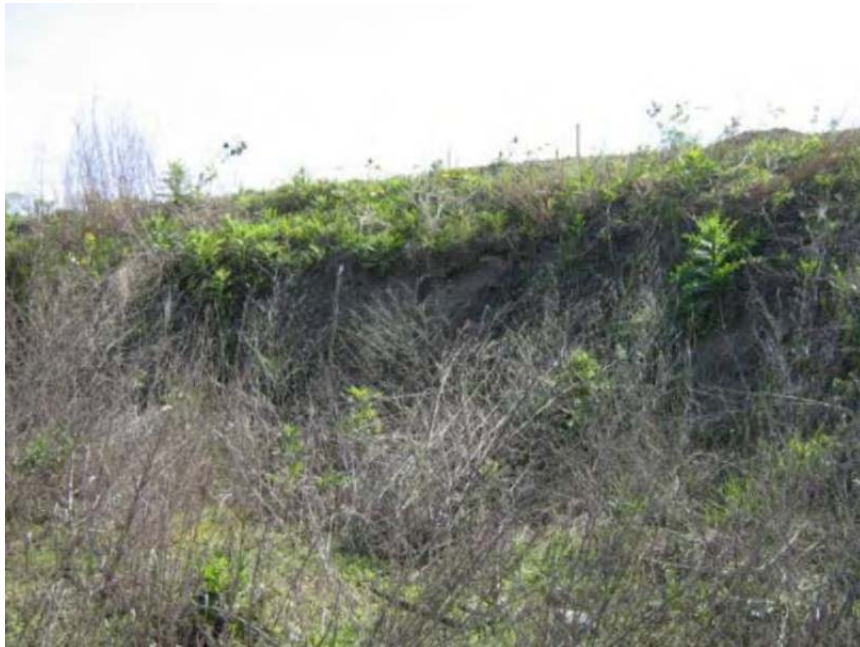
77. Ash Pond 3 - Scarp along West Embankment Interior Slope
(Approximately 18 feet Long by 5 feet in Height)

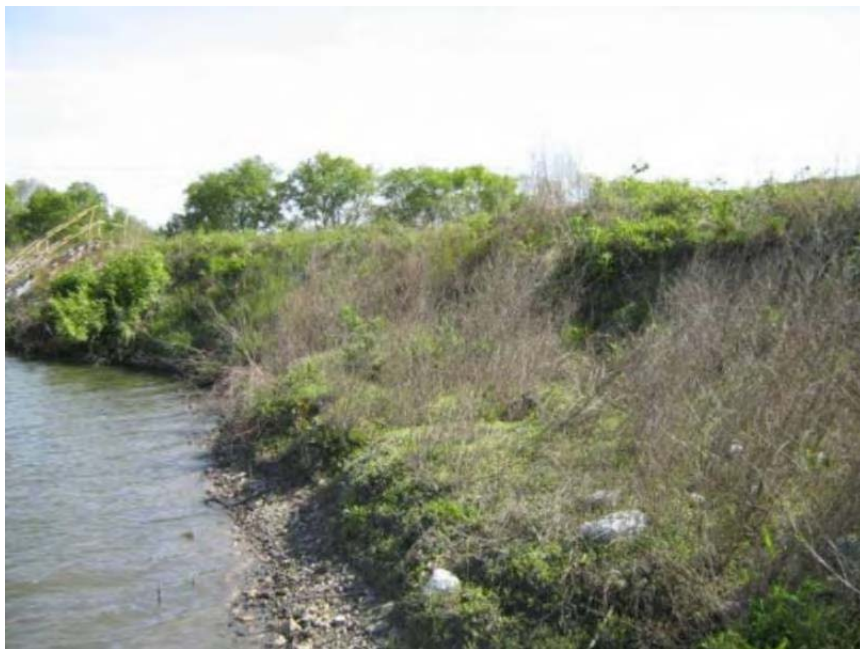
78. Ash Pond 3 - Scarp and Beaching along West Embankment
Interior Slope

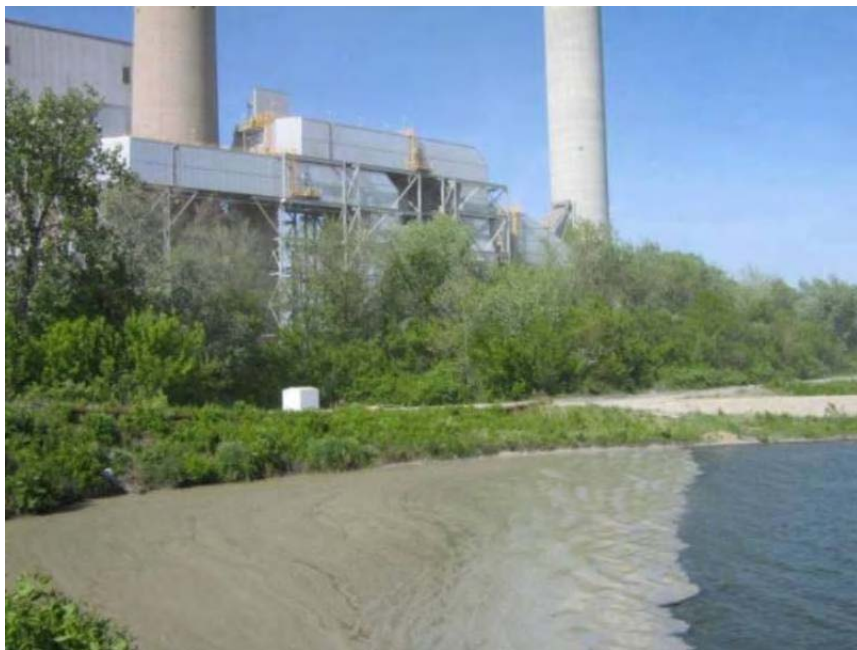
80. Ash Pond 3 - Fines in Northwestern Corner of Pond

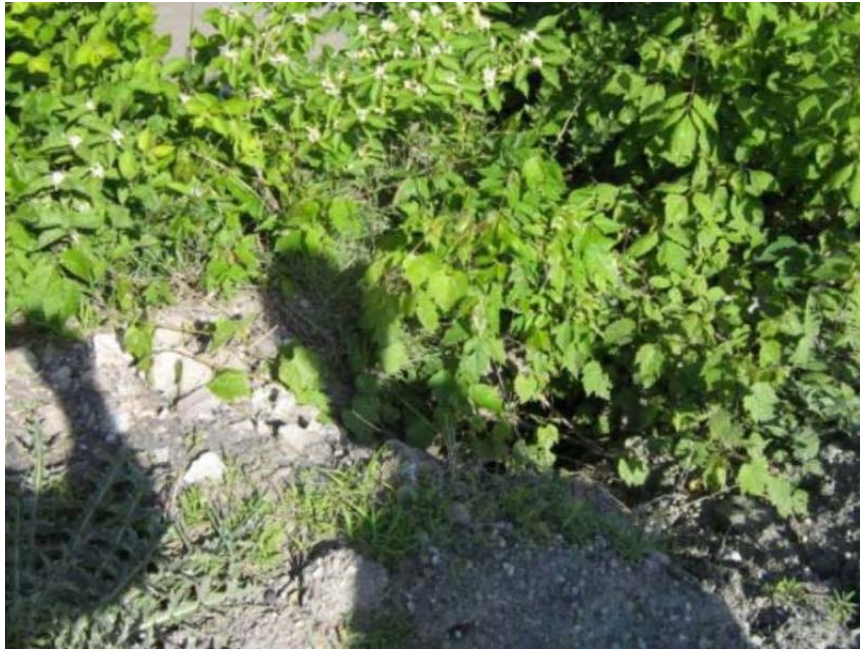
81. Ash Pond 3 - Surface Erosion at top of West Embankment
Interior Slope

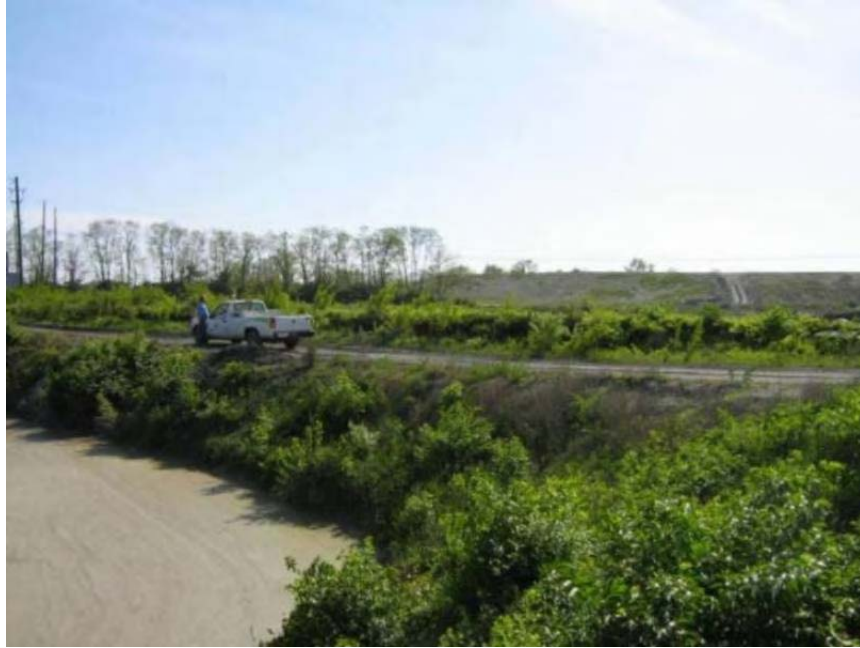
83. Ash Pond 3 - Vegetation on West Embankment Interior Slope,
Looking West

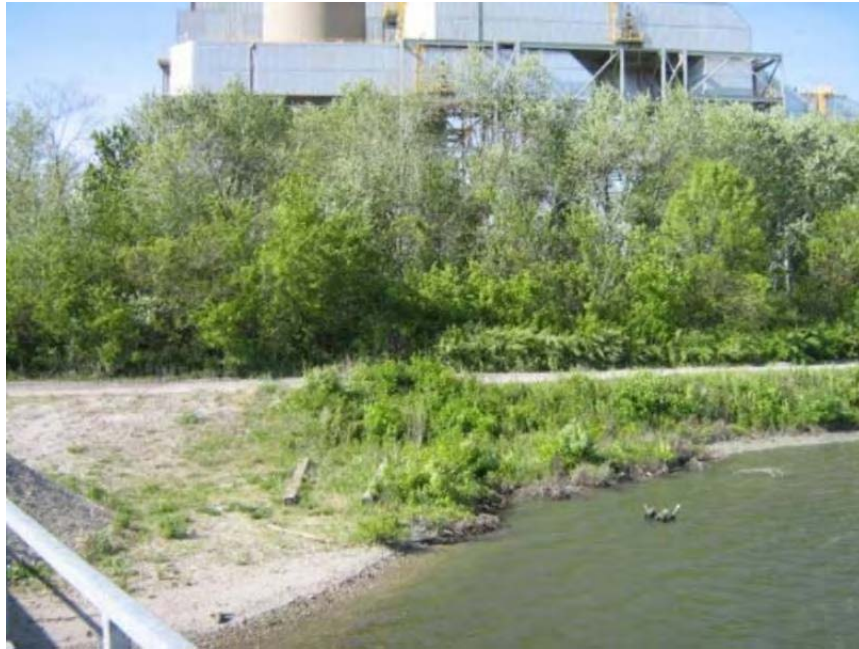
85. Ash Pond 3 - North Embankment Interior Slope, Looking North
From Outlet Control Structure

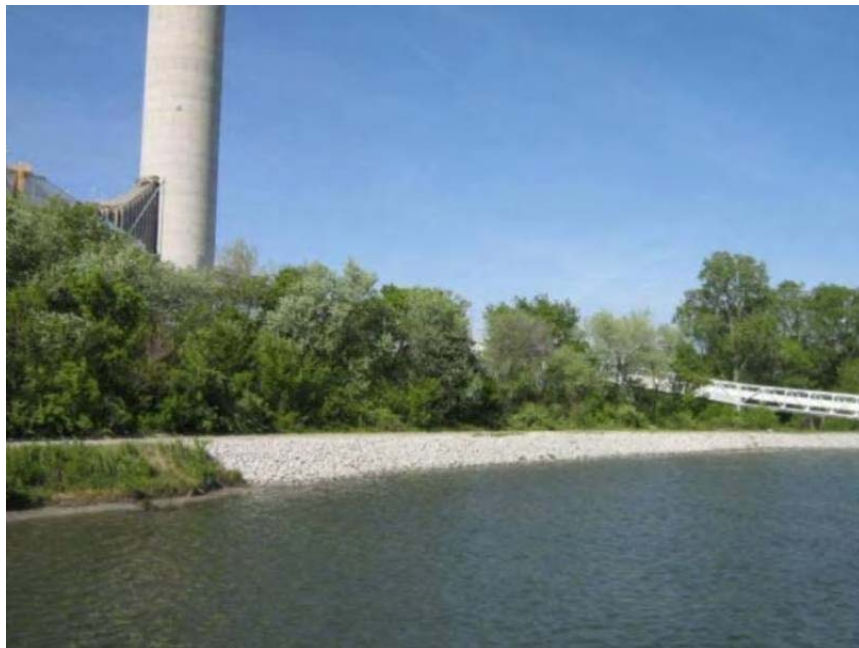
86. Ash Pond 3 - North Embankment Interior Slope, View from
Outlet Control Structure

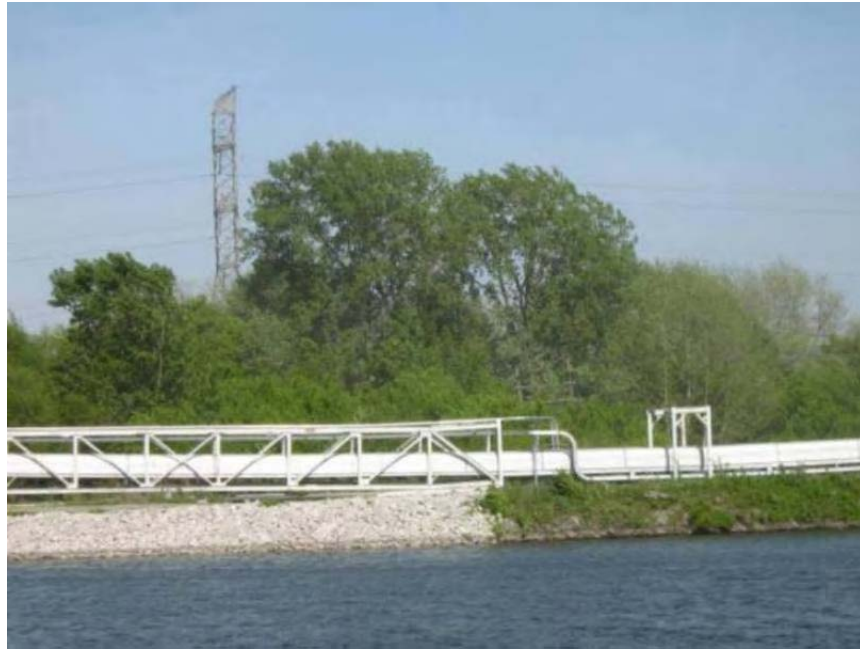
87. Ash Pond 3 - East Embankment Interior Slope, View from Outlet Control Structure

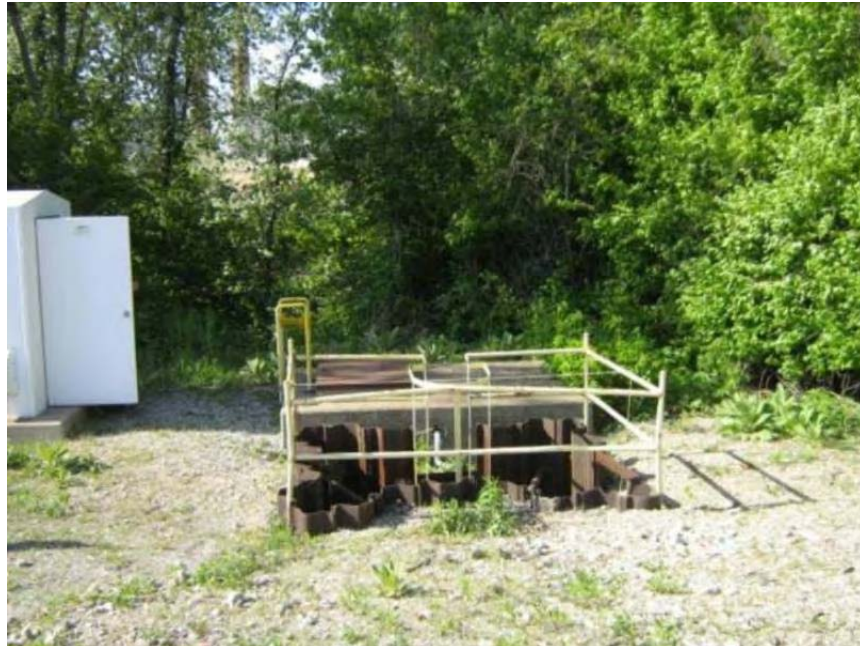
89. Ash Pond 3 - Ash Pond 3 Drop Inlet Structure/Discharge to Lick Creek, Looking North

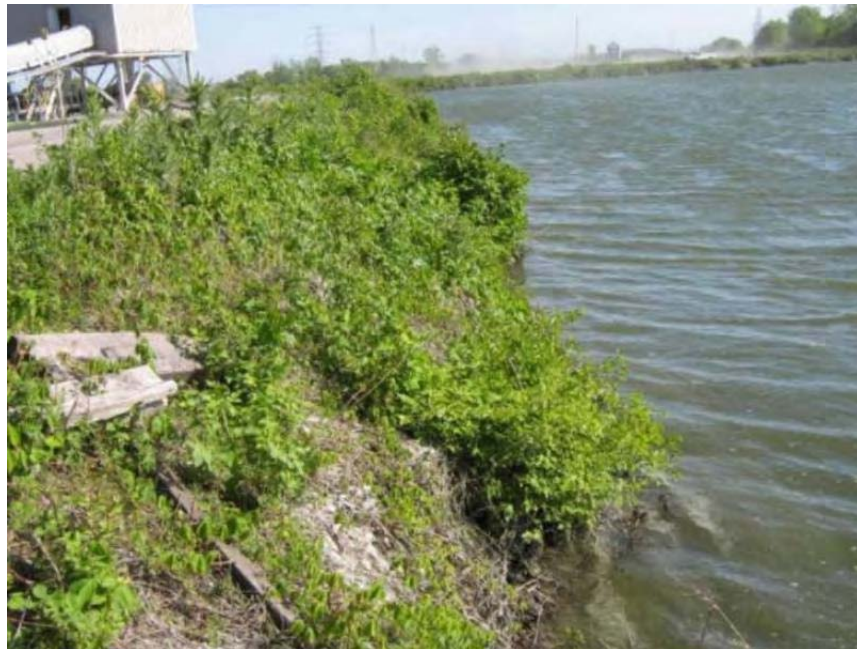
91. Ash Pond 3 - Beaching Along East Embankment Interior Slope,
Looking South

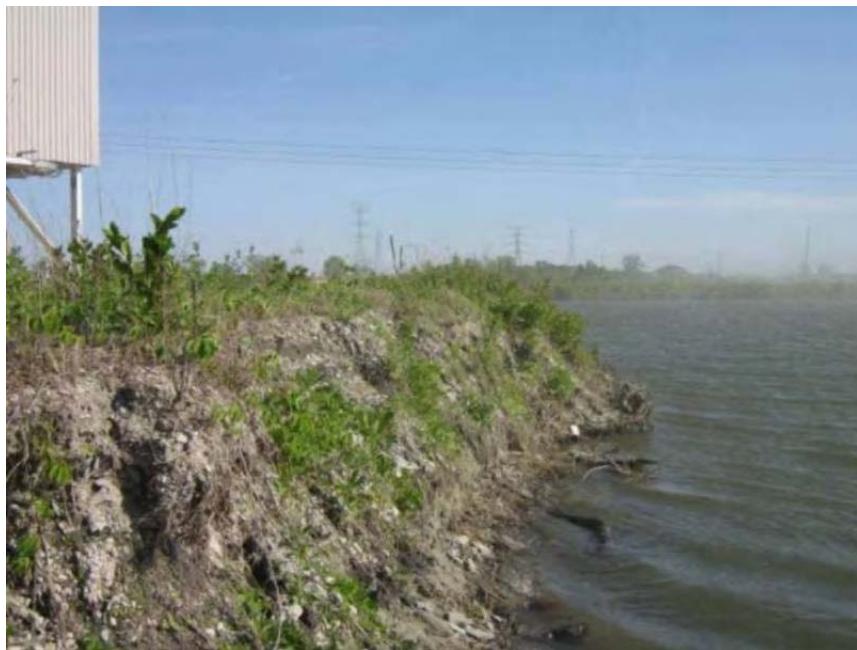
92. Ash Pond 3 - East Embankment Interior Slope, Looking South,
Extensive Erosion and Steep Slopes

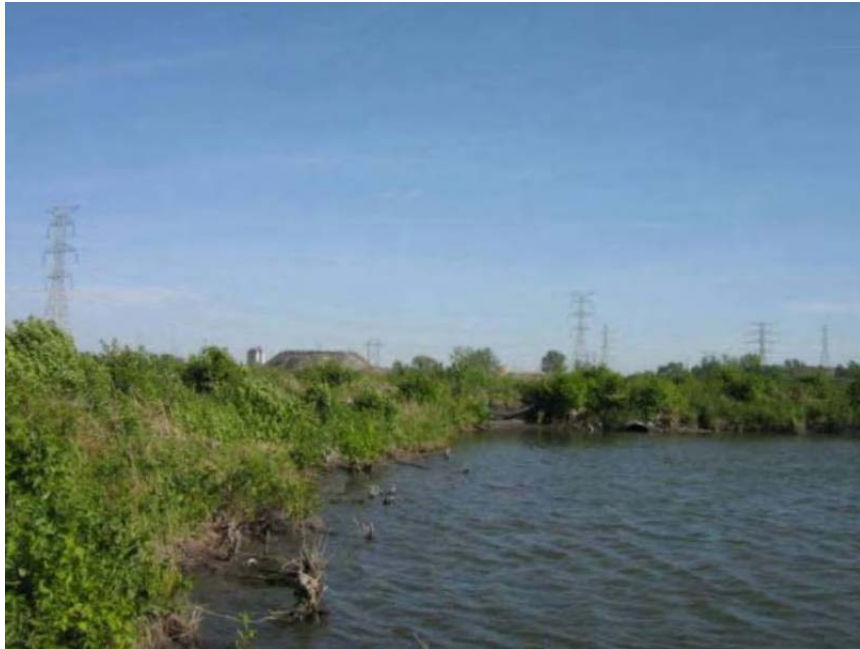
95. Ash Pond 3 - Southeastern Embankment Interior Slope, Looking South, Vegetation

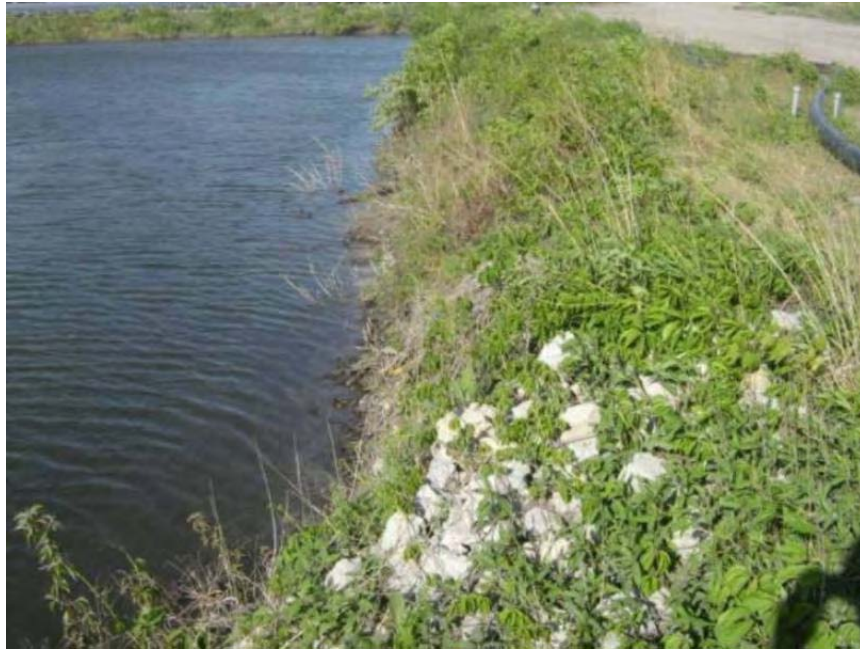
97. Ash Pond 3 - South Embankment Interior Slope, Looking East

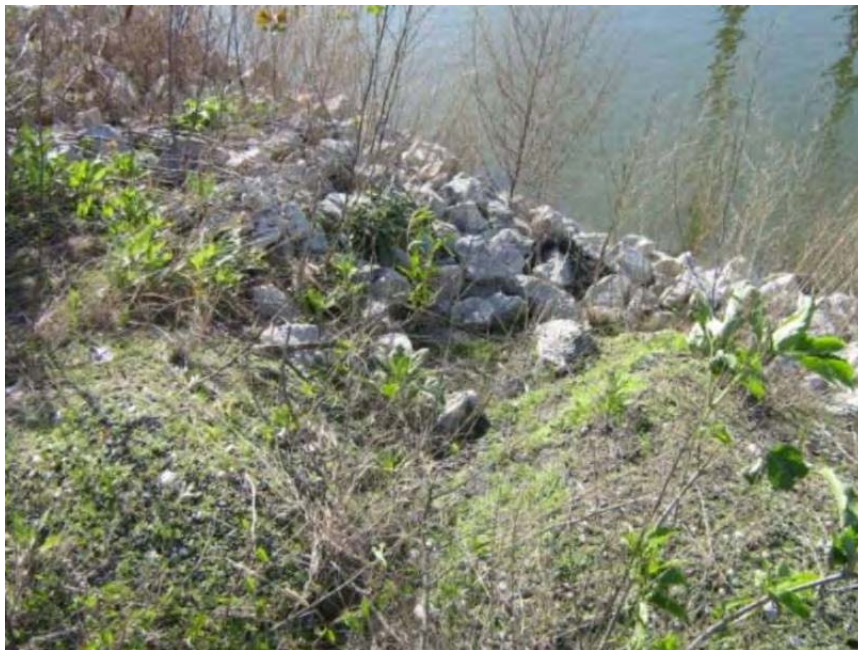
98. Ash Pond 3 - Erosion Rill above and Adjacent to Riprap along South Embankment Interior Slope

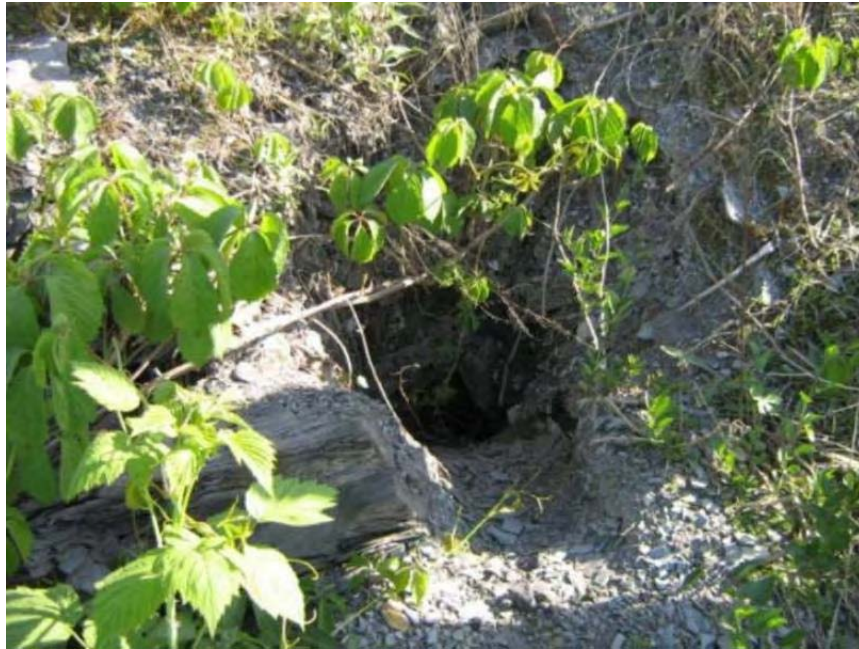
99. Ash Pond 3 - Rodent Burrow located in South Embankment Interior Slope

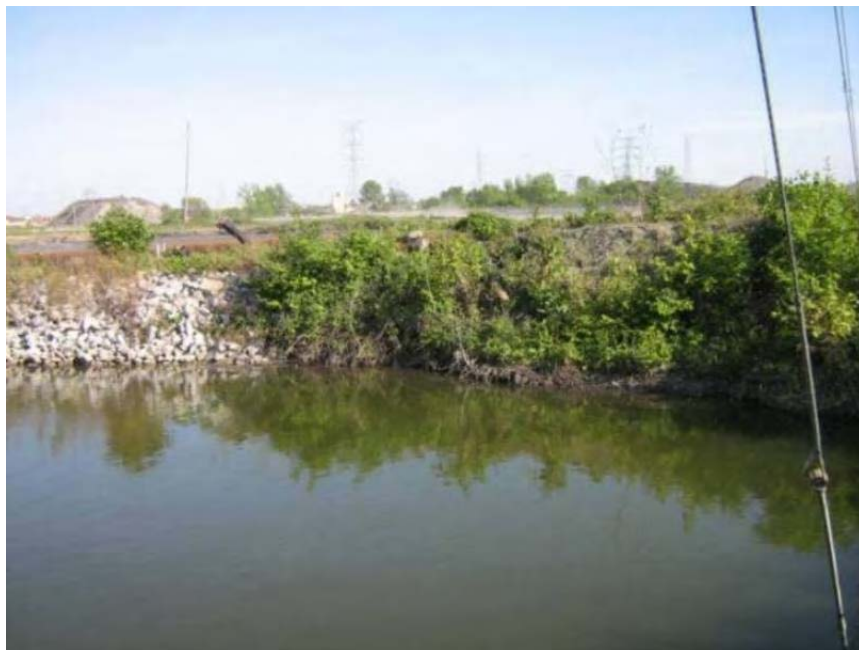
100. Ash Pond 3 - South Embankment Interior Slope, Looking South

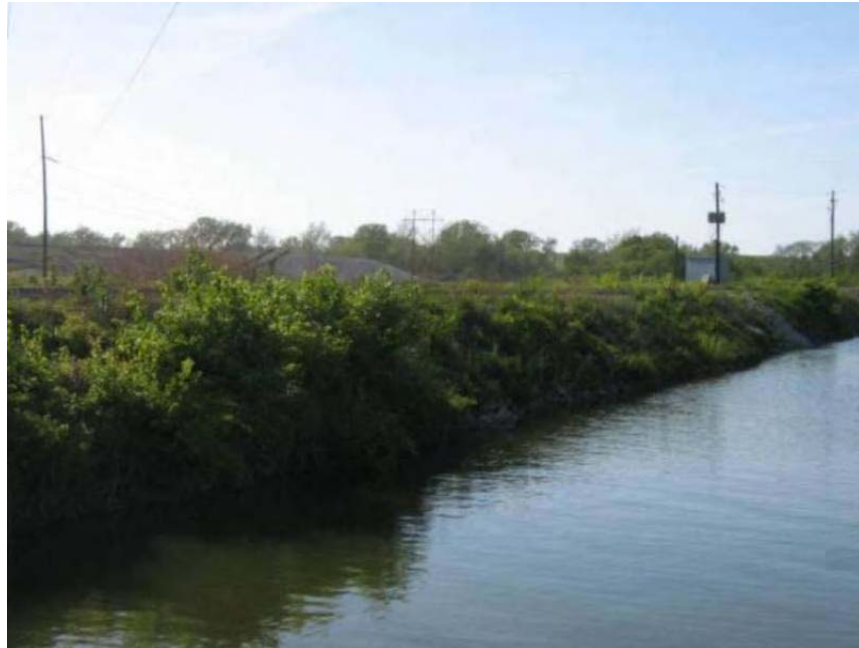
101. Ash Pond 3 - West Embankment Interior Slope, Looking North,
Slope is Undercut

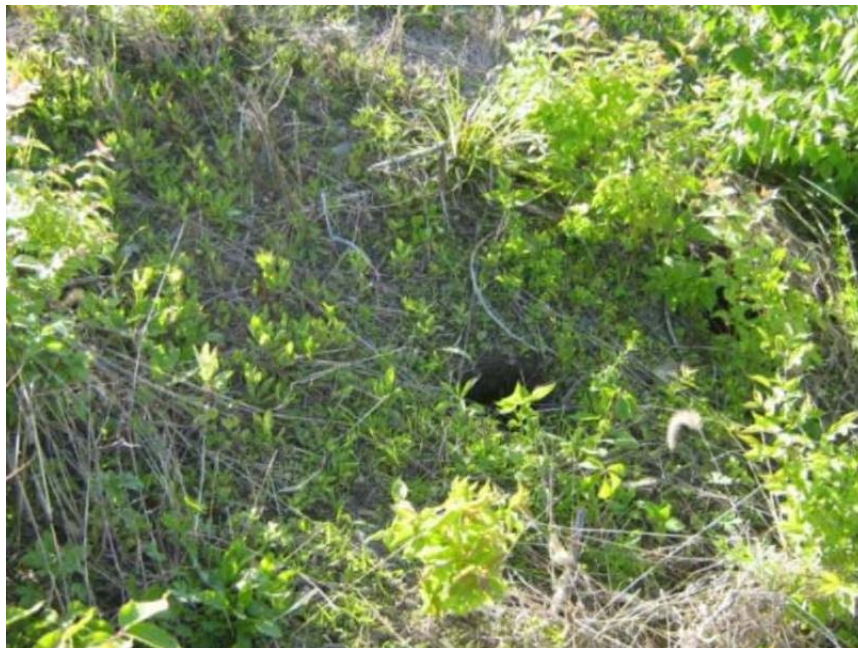
102. Ash Pond 3 - Rodent Burrows in West Embankment Interior
Slope

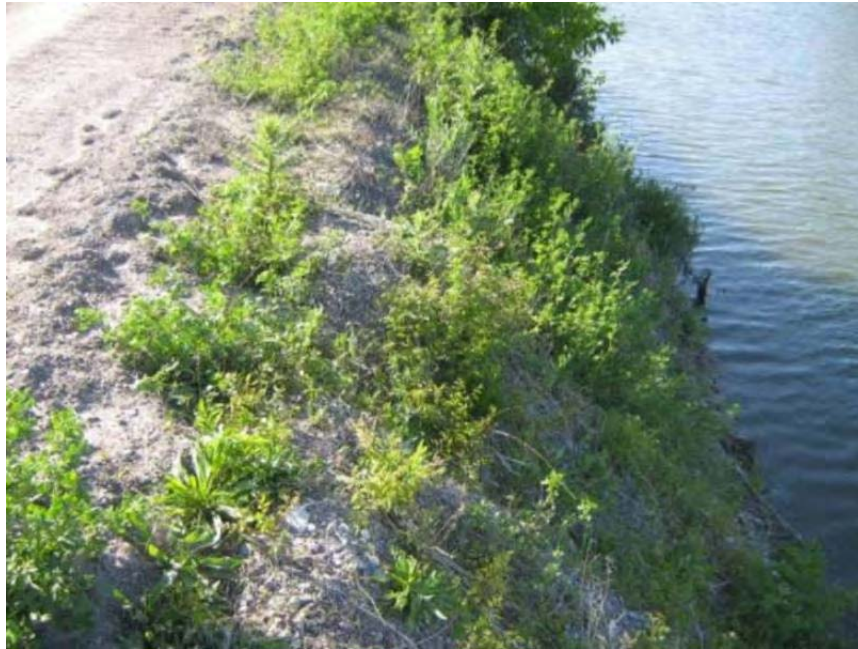
103. Ash Pond 3 - Erosion Rills and Beaching on West Embankment
Interior Slope

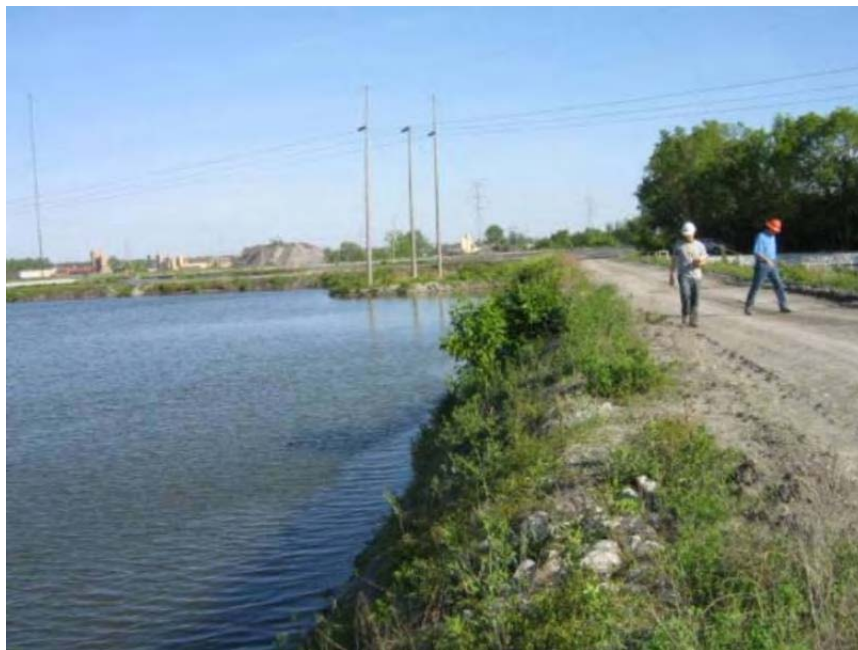
104. Ash Pond 3 - West Embankment Interior Slope, Looking South

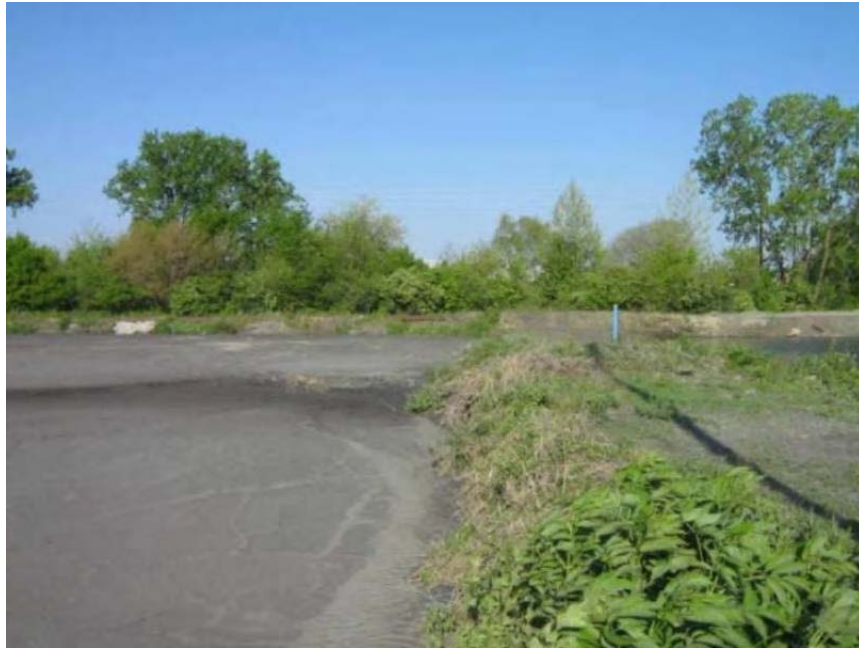
105. Ash Pond 4 - North Embankment Interior Slope, Looking West

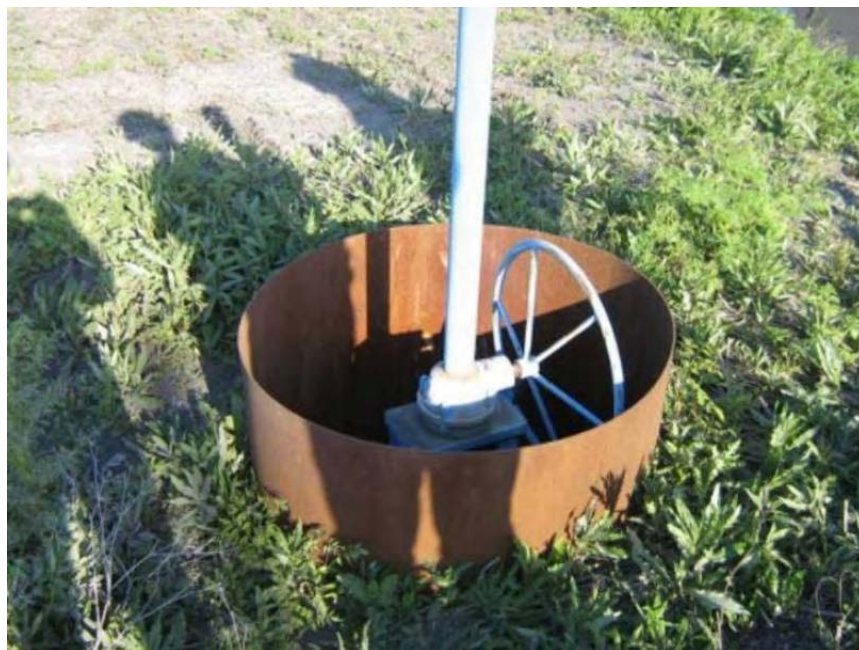
106. Ash Pond 4 - Gate Valve located on North Embankment Crest
